**Flood Control Project Maintenance
Levee Inspections**

Fall 2018 Levee Maintenance Deficiency Summary Report

Reclamation District No. 2064 River Junction

Waterway			Bank	Unit Miles
Unit No. 01 San Joaquin River			Right	5.56
	Spring (March - May)	Summer (June - August)	(September - November) Fall	Winter (December - February)
Unit Maintenance Rating (Fall Only)			A	
Date of Inspection	4/11/2018 - 4/11/2018		10/5/2018 - 10/5/2018	
DWR Inspector	Keith Millard		Luz Dial	
Accompanied By	Mark Veltkamp RD 2064		Keith Veltkamp RD 2064	
	Dan Eavenson		Dan Eavenson

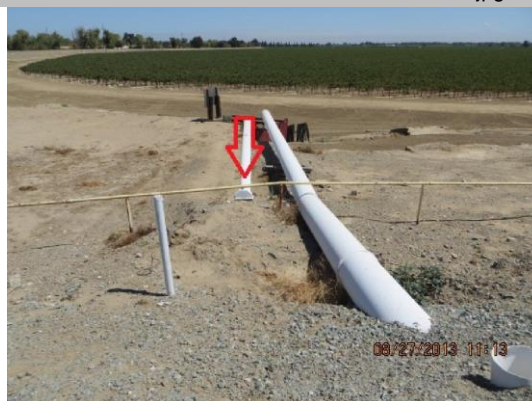
Photo 1 of 3 : UCIP_FA_2018_19044_31844.jpg

Pipe and gate valve on LS toe.

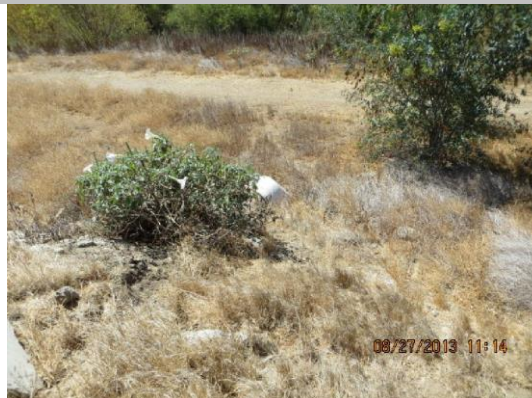
Photo 2 of 3 : UCIP_FA_2018_22733_38467.jpg

Pipe visible on WS slope.

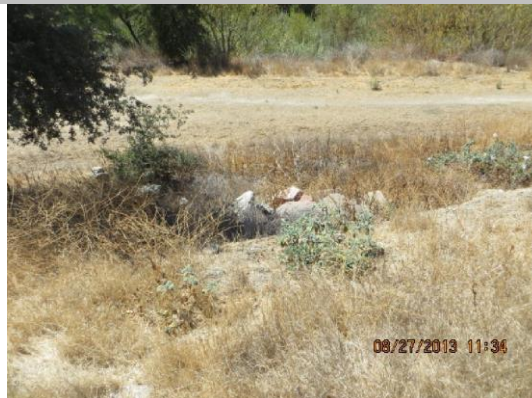
Photo 1 of 2 : UCIP_FA_2018_19046_31849.jpg

Concrete rubble on WS slope possible indicator of abandoned pipe location.

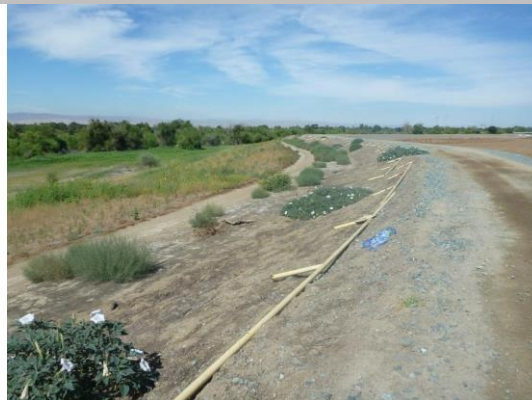
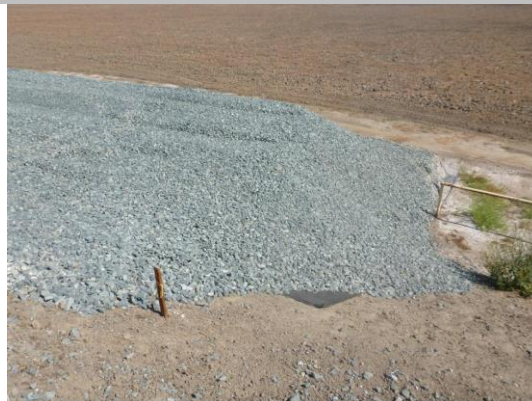
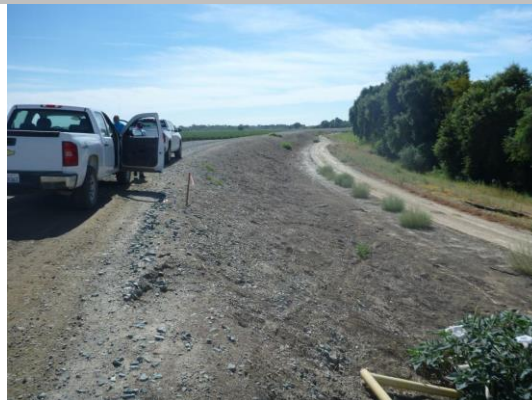
LM Start	3.92	Rating **	A/W	Issue No.	24
LM End	4.03	Issue Type +	Ob	Location *	
Category	Supplemental			GPS Latitude/Longitude	
				Start	End
Item	2017 Storm Damage			37.673190 °	37.672180 °
				-121.258140 °	-121.256490 °
DWR ID	DWR_RD2064_01_f_2017_24				
Comment Code					
Inspector Comment					
Levee Evaluation Comments					
Description:The damaged area is due to extensive seepage occurring from high river flows, especially when the water level is above 25.0' at the Vernalis Gauge. The damage is from long-term saturated soil within the levee structure beyond the landside toe. This area is an extension of a seepage berm placed on an emergency work order in February 2017.					
Site ID No:581					
Site Designation:LMA-487					
Repair Type: Seepage					
Rating:Area of Concern					
Field Date:8/14/2017					
Notes:

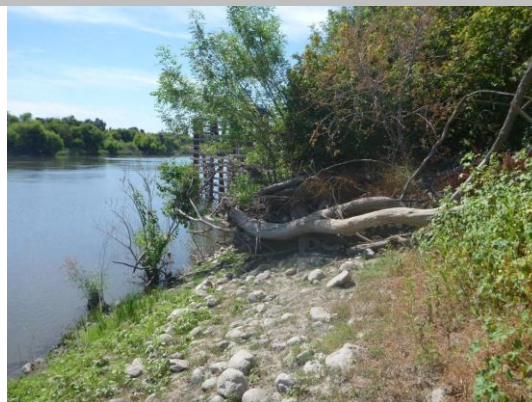
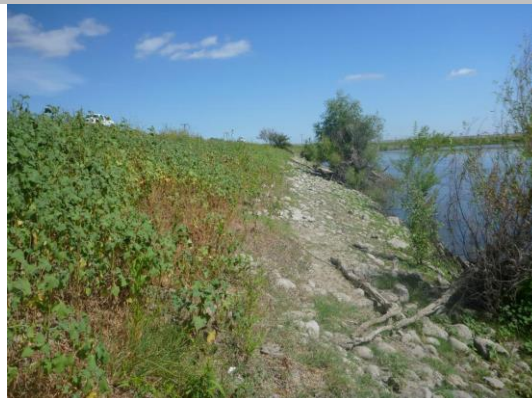
LM Start	4.82	Rating **	A/W	Issue No.	26
LM End	4.85	Issue Type +	Ma	Location *	
Category	Supplemental			GPS Latitude/Longitude	
				Start	End
Item	2017 Storm Damage			37.671730°	37.672140°
				-121.246820°	-121.246800°
DWR ID	DWR_RD2064_01_f_2017_26				
Comment Code					
Inspector Comment					
Levee Evaluation Comments					
Description:Erosion from high water flows caused erosion scarps from 12" to 24" in height. The area of damage is approximately 600 feet in length.					
Site ID No:583					
Site Designation:LMA-489					
Repair Type: Erosion					
Rating:Area of Concern					
Field Date:8/14/2017					
Notes: Minor toe erosion

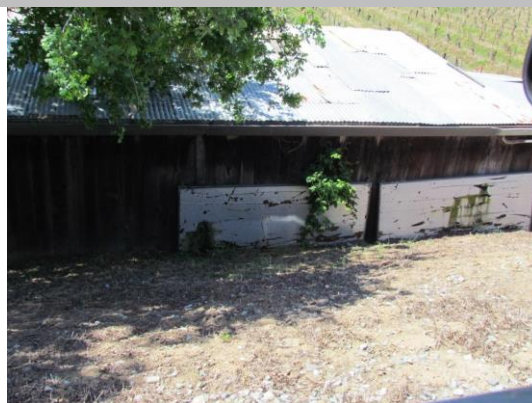
Photo 1 of 1 : FA_2018_RD2064_314_17_20180910_00001.jpg

LM Start	1.77	Rating **	U	Issue No.	17
LM End	1.85	Issue Type +	En	Location *	LS
Category	Earthen Levee			GPS Latitude/Longitude	
				Start	End
Item	Encroachments			37.673714 °	37.674829 °
				-121.222345 °	-121.222822 °
DWR ID	DWR_RD2064_02_s_2017_17				
Comment Code					
BU : Building					
Inspector Comment					
LMA manager currently working with Board to take action on several encroachments (buildings, sheds, vehicles, equipment, debris, etc.).

RD 2064 looking upstream from levee mile 1.96 landside, building within the easement.

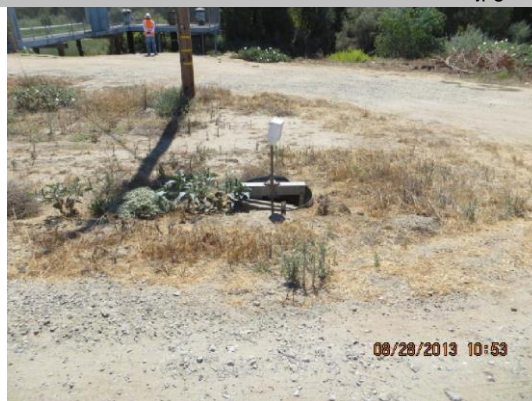
Photo 2 of 3 : UCIP_FA_2018_41075_31962.jpg

Slide gate in 36-inch CMP riser on WS slope.

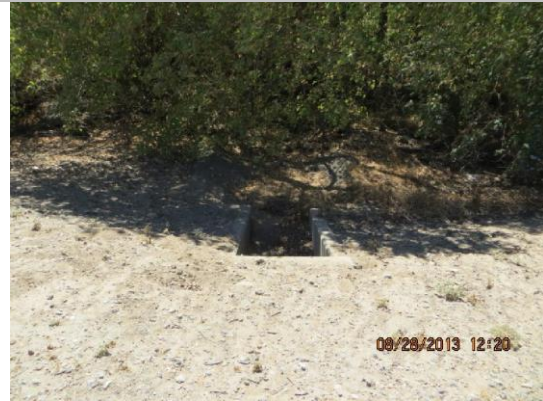
Photo 2 of 3 : UCIP_FA_2018_19122_32082.jpg

Concrete headwall on WS toe.

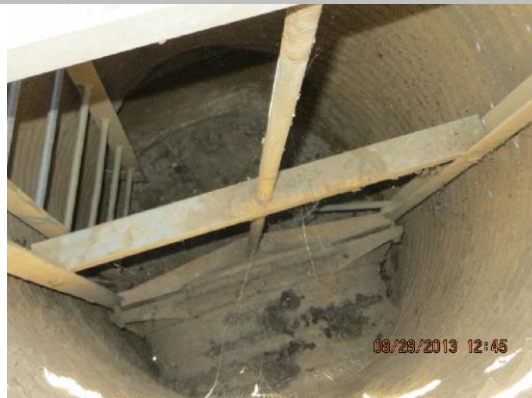
Photo 2 of 2 : UCIP_FA_2018_19145_32125.jpg

Pipe in CMP riser on WS slope.
